Appendix 4
HABITAT QUALITY, BIOTIC CHARACTERIZATION, AND FISH PASSAGE
ASSESSMENT OF
WATER DIVERSIONS ON NINE TRIBUTARIES IN THE
SOUTH FORK OF THE TRINITY RIVER WATERSHED, TRINITY COUNTY, CA
By

Samantha D. Chilcote, PhD

February, 2016

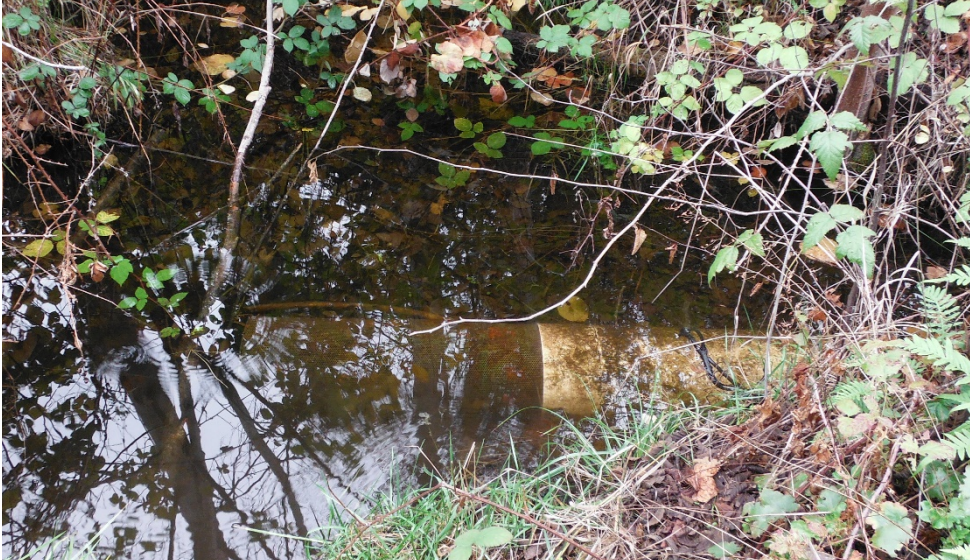
The diversion channel had a 3.18 mm fish screen and no approach velocity issues.

Figure 6. Diversion tube intake with fish screen at Olsen Creek.

The CDFW standard fish screen mesh size is 2.38 mm (CDWF, 2016).

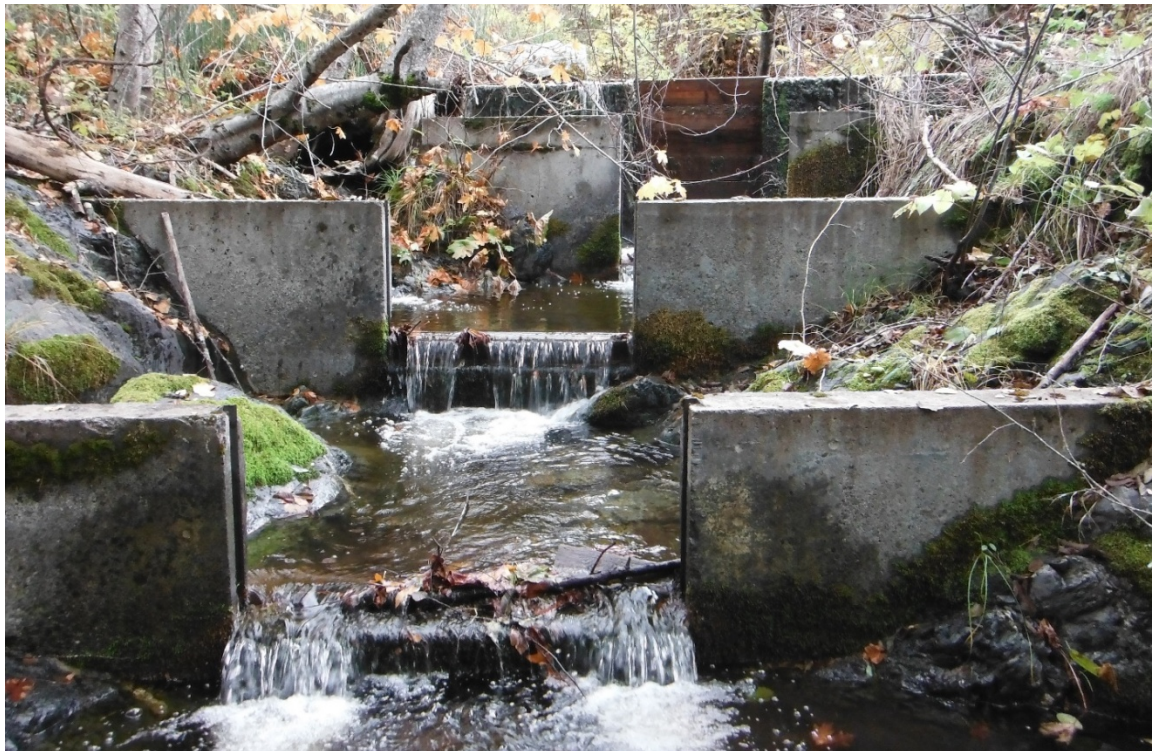
The fish passage structure was comprised of four permanent concrete structures with wooden boards which could be removed and inserted to control flow.

Figure 7. Fish passage structure at Olsen Creek.

Two of the fish passage structures had sufficient flow, jumping pool depth (jump height to landing pool depth 1:1.25 or better (Taylor, 2011)), as well as a vertical rise less than 0.15 meters to allow fish passage for all life history stages of salmonids. However, the other two passage structures had vertical

elevations greater than 0.15 m, 0.20 m and 1.5 m, respectively. This was due to the fact that there were 1 and 5 boards, respectively, placed in the concrete notch. Management recommendations would be to manage board placement relative to creek flow and potentially retrofit the structure to allow landowner diversion needs to be met while ensuring adequate fish passage for all salmonid life history stages. Conversations with the landowner found that the fish passage structure had been retrofitted by CDFW once already and they stated they would maintain the structure. To their knowledge this structure and board placement has not been maintained by CDFW. There are no downstream fish barriers.

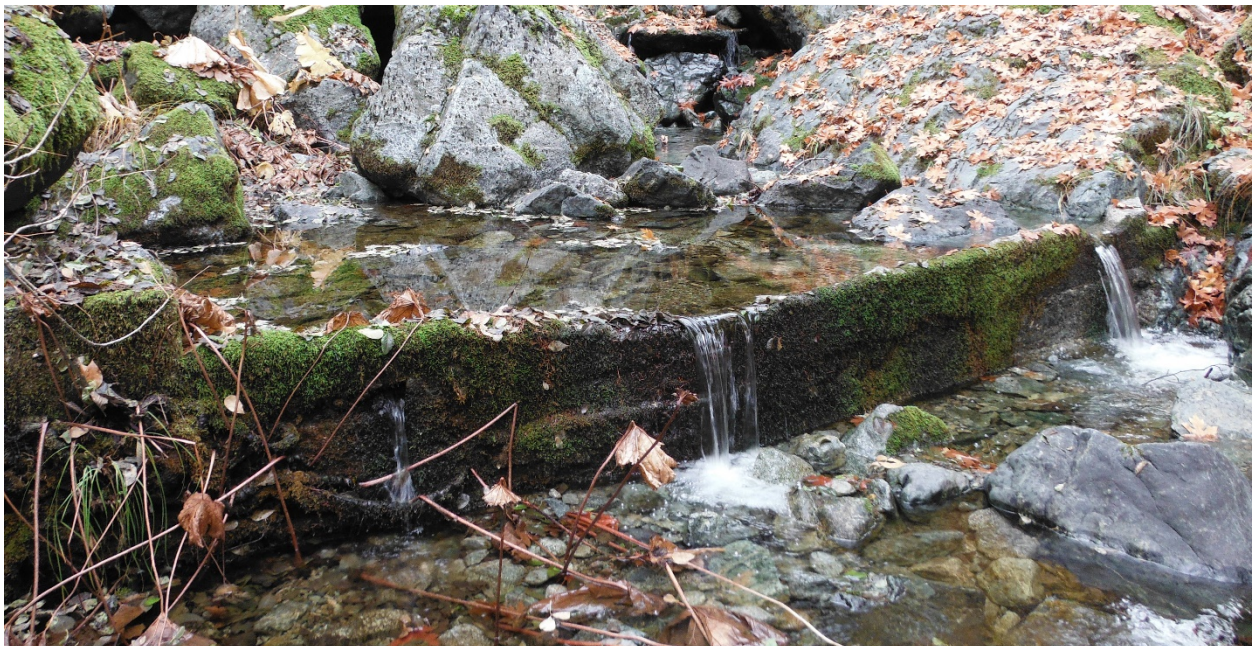
Silver Creek had the highest salmonid species richness, containing both rainbow/steelhead complexes as well as juvenile chinook salmon. There is a permanent diversion structure with no fish passage.

Figure 8. The diversion dam at Silver Creek.

There is no fish passage structure associated with the diversion. The structure was a total barrier to all life history stages at the survey flows due to insufficient jumping pool depth (Taylor, 2011) as well as the vertical height for juveniles (Whitman, 2011).

This diversion structure represents a high priority restoration opportunity because the structure is no longer being used to divert water from the creek. Therefore, it represents a fish barrier with no beneficial uses.

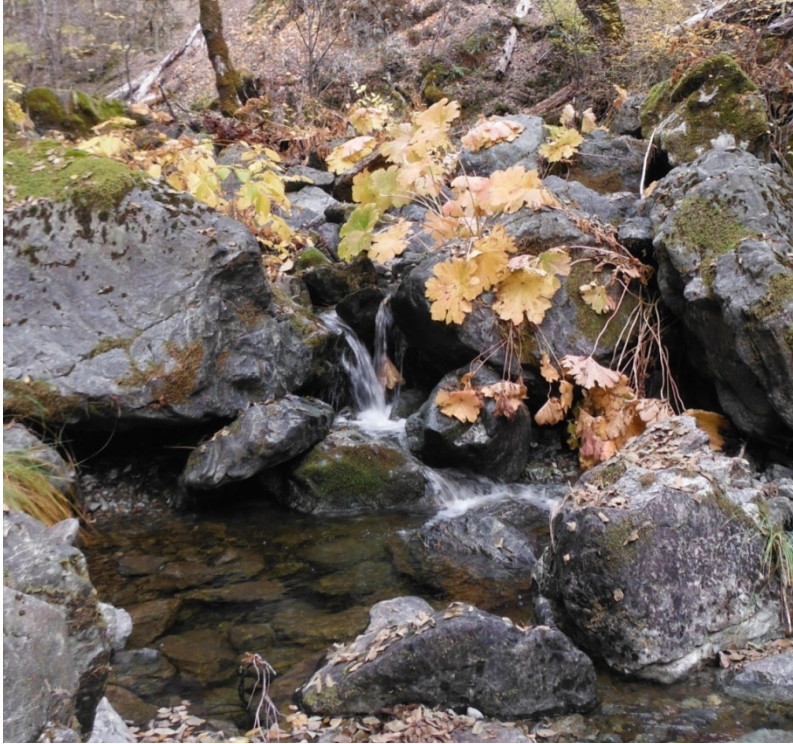
Figure 9. The natural partial fish passage barrier downstream of the diversion on Silver Creek.

This would likely not be a barrier to all life history stages at all flows.

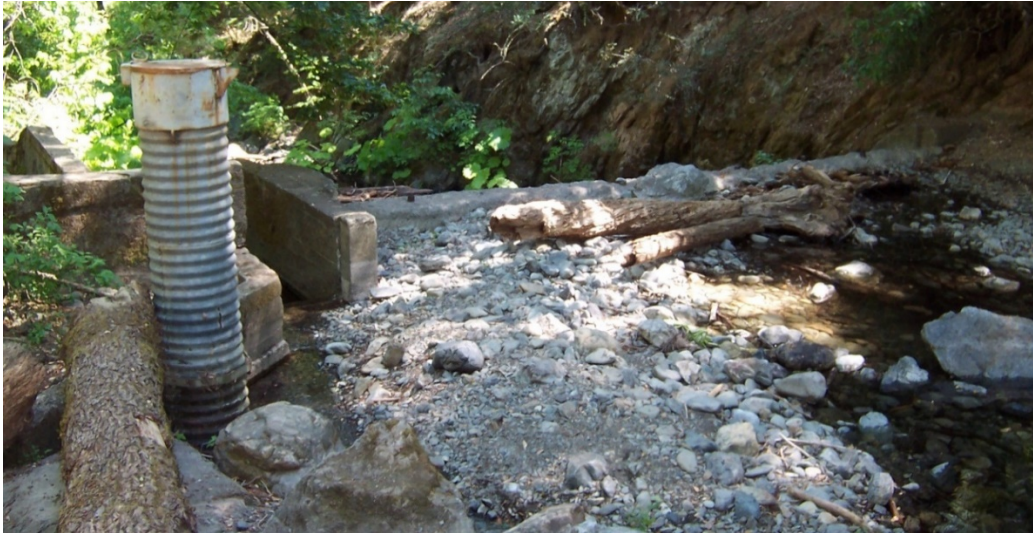
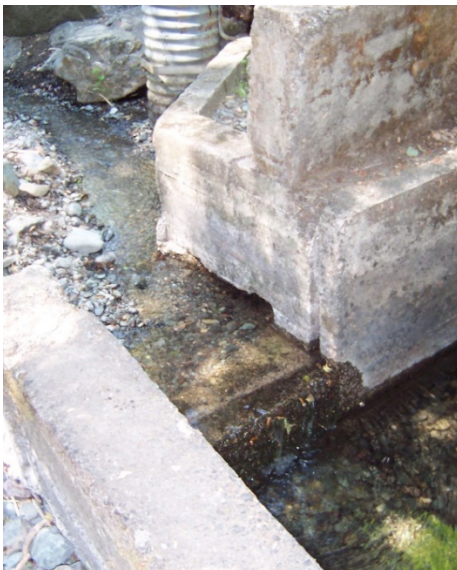
There was no flow over the diversion structure at the time the survey was conducted. There was surface water downstream of the diversion structure due to subsurface flow. There was minimal surface flow through the fish passage structure.

Figure 10. Big Creek upper diversion flows over diversion structure (a) and into the fish passage structure (b).

The majority of surface flow was diverted into the diversion channel.

The adult steelhead were likely trapped in upper Big Creek and its diversion channel once water began to be diverted at the beginning of the growing season. There was not sufficient surface flow over the diversion structure or through the fish passage structure to allow out migration of the adult steelhead. Shortly after the survey occurred, a small storm raised water levels in the stream enough for the adult fish to exit the system (pers. comm. Murrison 2015), although it was not verified that this occurred. Therefore, a priority management recommendation would be to ramp up flows into the diversion channel more gradually, giving the adult steelhead a hydrologic cue to out-migrate, or to maintain sufficient flow through the fish passage structure year round to allow fish passage.

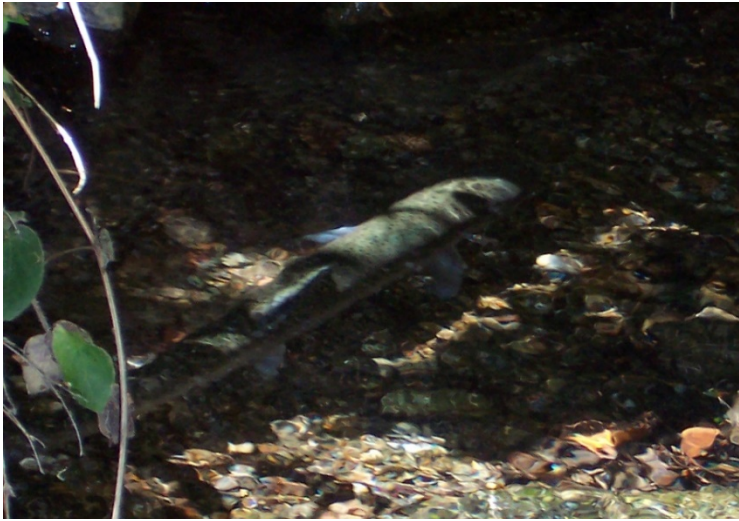
Figure 11. Adult steelhead in the diversion channel of Big Creek.

This suggests Big Creek is an important tributary for the spawning and rearing of anadromous fish populations in the South Fork of the Trinity River.

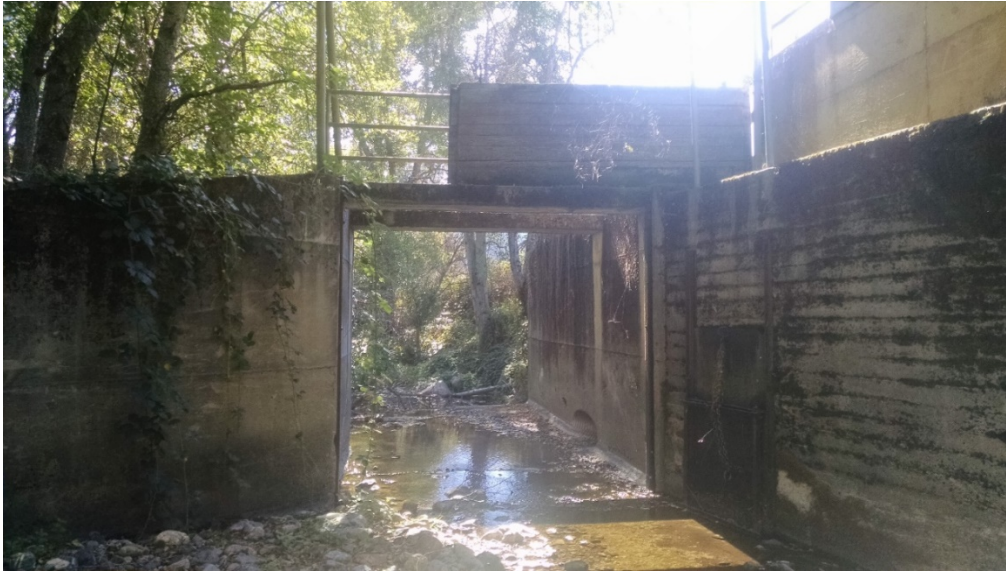
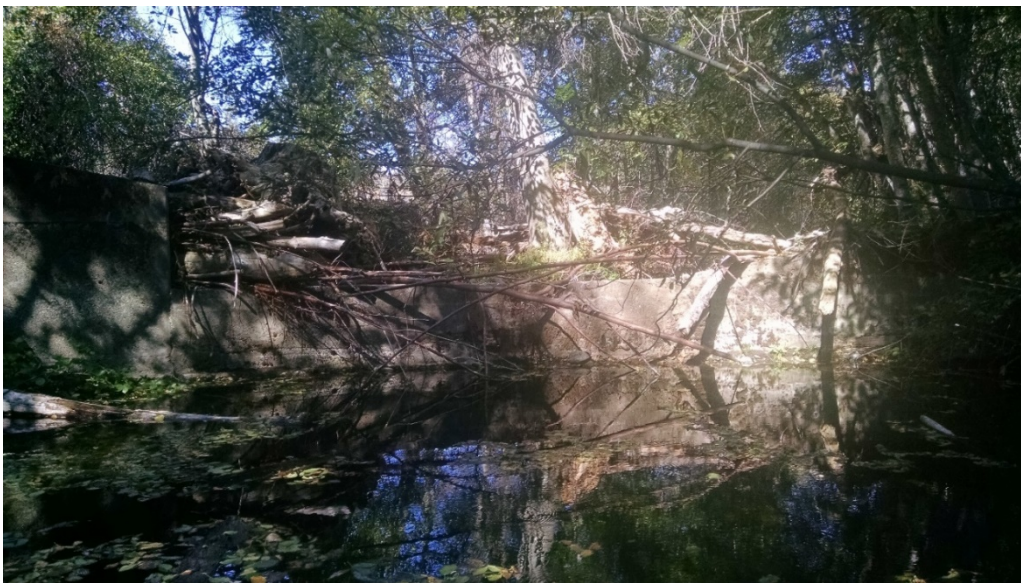
There is a permanent concrete diversion structure on lower Big Creek. This structure extends across the main channel as well as a secondary channel on the tributary to Hayfork Creek.

Figure 12. The lower diversion structure on Big Creek. on the primary channel looking downstream with the diversion gate and screen on the right (a) and on the secondary channel looking upstream (b).

The diversion gate did not appear to be in use. There is no fish passage structure on either channel.

Rainbow/steelhead complexes were found above and below the diversion structure. Speckled dace were also found below and above the diversion structure. However, their abundance was much higher below the diversion structure. The flow through the lower diversion structure on Big Creek is greatly reduced by the diversion of all surface water at the Upper Big Creek Diversion structure, discussed above. The reduction in water quantity likely contributes to warmer water, encouraging the presence of warm water associated species such as speckled dace. Currently, this structure may be slowing the upstream spread of speckled dace.

There are several potential management recommendations for this structure. The structure is no longer in use. Therefore, the ideal management action would be to remove it. This action in conjunction with decreased diversion of surface flows at the upper diversion structure on Big Creek would allow passage of all fish life history stages and potentially limit the upstream spread of warm water associated species, such as speckled dace. However, an alternative strategy would be to install a fish passage structure on either the main channel or secondary channel structure with sufficient attraction flows that is less than 0.15 m high. This will allow passage of juvenile salmonids but also potentially limit the upstream distribution of speckled dace as they have much weaker swimming abilities than salmonids (Monk and Hotchkiss, 2012). It is important that management of both the lower and upper diversions structures is considered in the restoration and improvement of this valuable tributary.

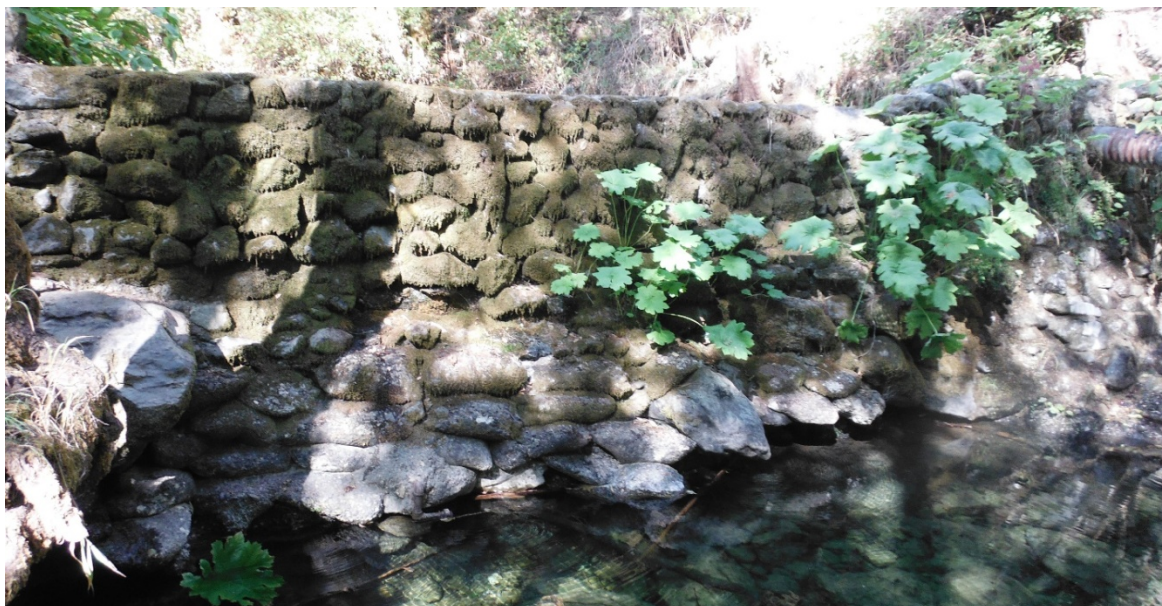
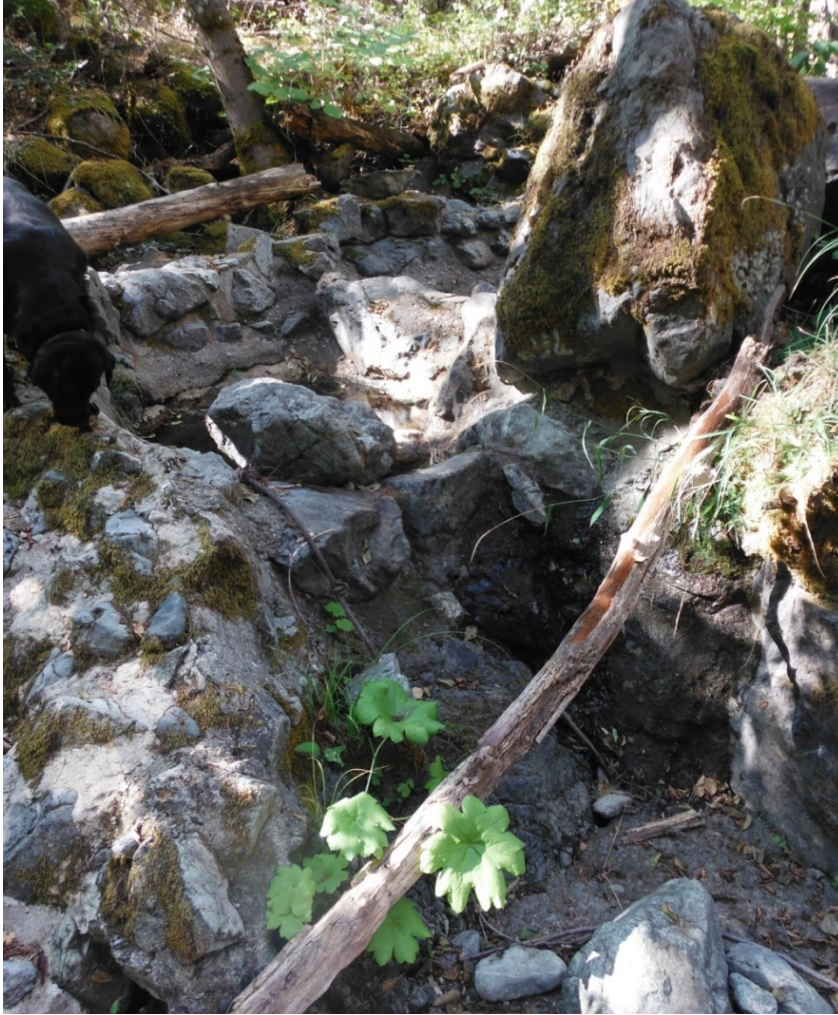
Upper Tule Creek has a permanent stone and concrete diversion structure on this tributary to Hayfork Creek. It is equipped with a fish passage structure. There was no surface flow over the diversion structure or through the fish passage structure.

Figure 13. The Upper Tule Creek Diversion. Diversion structure and diversion pipe on the far right side of the photograph (a) and the fish passage structure (b).

CDFW maintains and monitors the screen on the diversion channel to its standards and specifications. The screen appeared to be properly functioning because no fish were found below the screen in the diversion channel during this survey.

The management recommendation for the diversion on Upper Tule Creek is to decrease diversion flows to allow surface flow through the fish passage structure. Alternatively, structures upstream of the diversion structure could also be added to divert surface flow through the fish passage structure. It was difficult to ascertain from current conditions the ability of the structure to pass all life history stages of salmonids if there was surface flow through the structure. Currently, the vertical elevation from any standing pools or the bottom of dry fish passage structures that a juvenile fish would have to jump to access the next fish passage structure ranged from 0.40 m to 0.90 m. Because typical jump distance for

The restoration recommendations for Upper Tule Creek diversion structure are similar to the upper diversion structure on Big Creek. Flow management would allow fish to potentially use the existing fish passage structure by maintaining minimal flows.

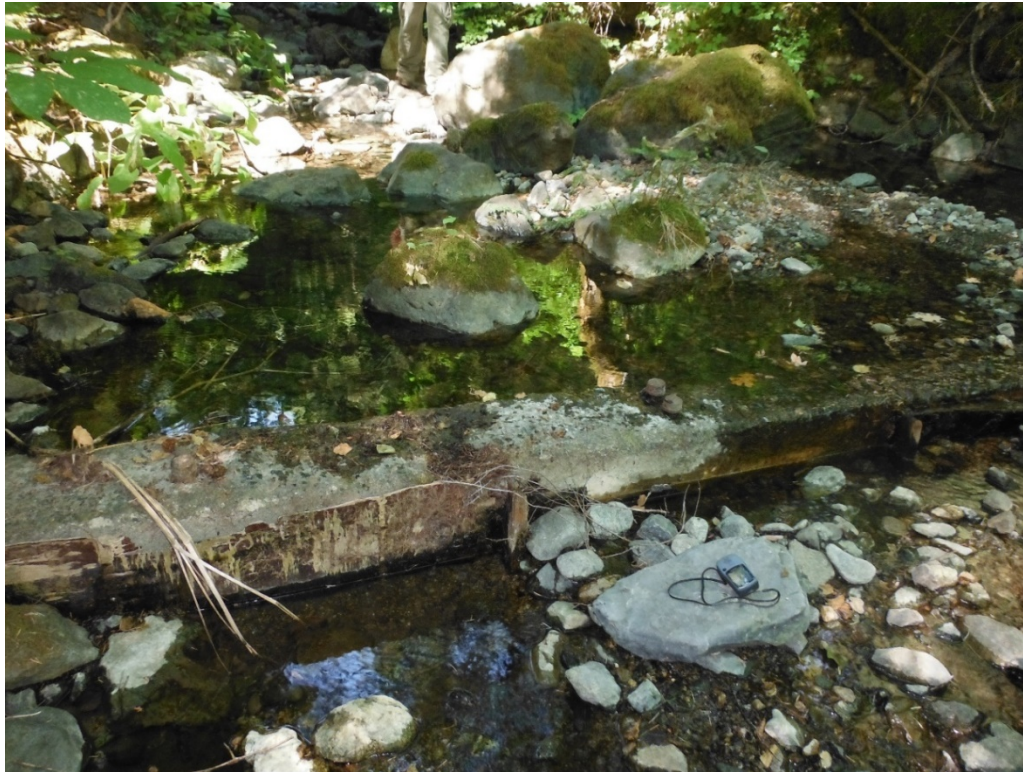
The West Tule diversion structure is a permanent concrete structure. There is no fish passage structure associated with the diversion.

Figure 14. The diversion on West Tule Creek.

The diversion structure was not actively operating during the survey due to extremely low flow in the creek. At this flow level, the diversion would be a barrier to fish passage at all salmonid life history stages due to insufficient jumping and landing depths. Additionally, the structure did interfere with the natural streamflow of West Tule Creek causing the flow to go subsurface for approximately 3m below the diversion structure. This is also a passage barrier for all life history stages of salmonids.

Management recommendations for this structure would be to retrofit it to another design that would not impede natural flow of the main channel, potentially by installing a tube screen or some other diversion device. This would restore the natural channel function and remove the concrete barrier to fish passage while maintaining diversion ability for beneficial uses.
