CARCD Conference Ventura, CA

Road Upgrades and Decommission TMDL Implementation in the Trinity River

Road Upgrades and Storm-proofing

Road Decommissioning

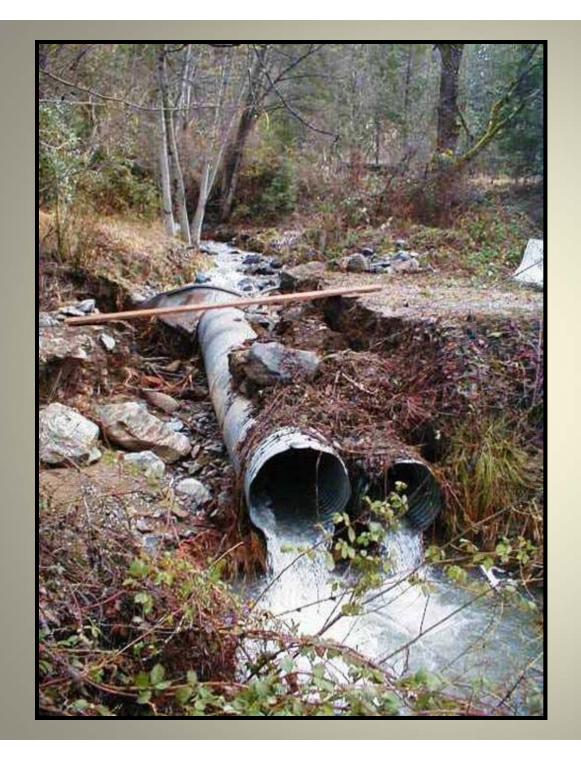
Upsize undersized culverts to meet 100-yr Flood flow event.

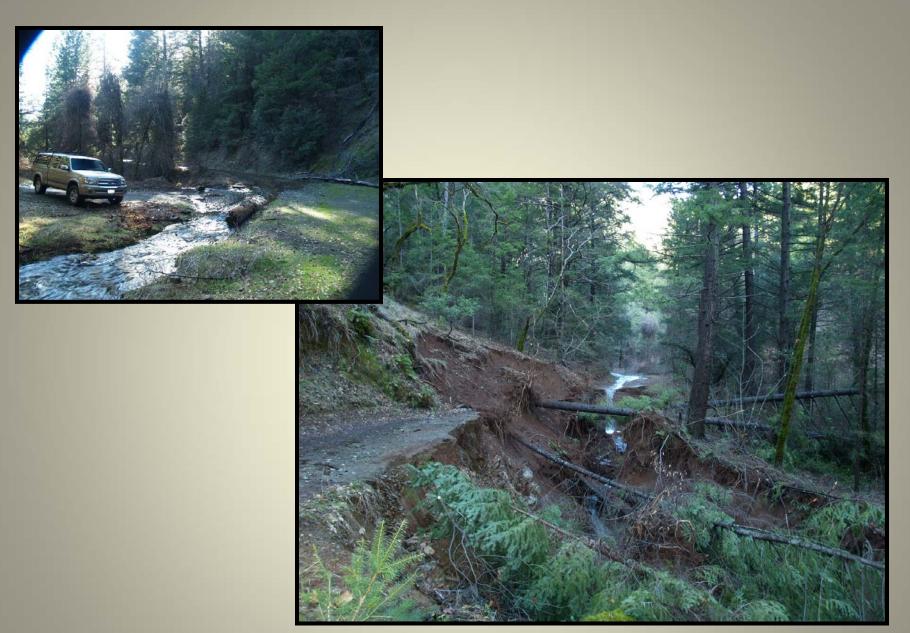
Eliminate Diversion Potential at all stream crossings

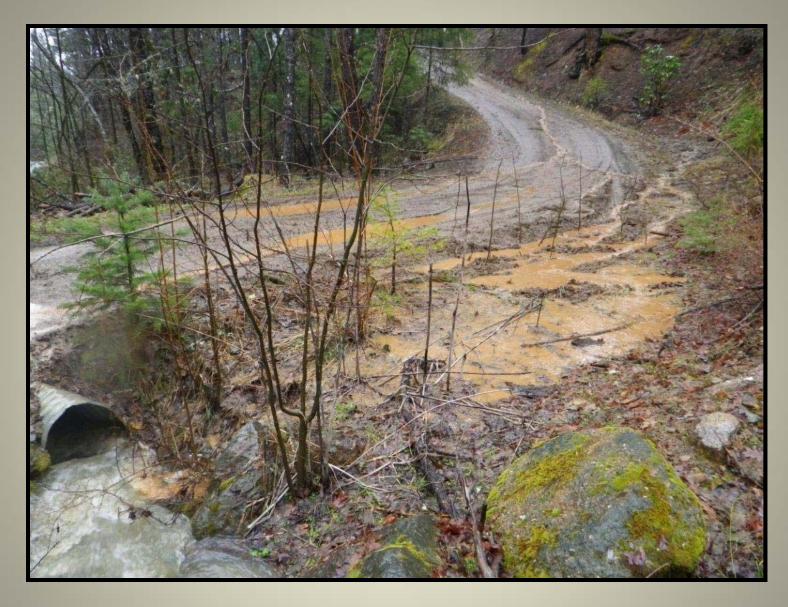
Disconnect ditches and road surface erosion from streams

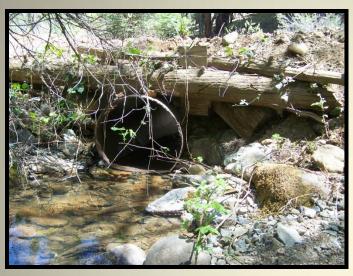
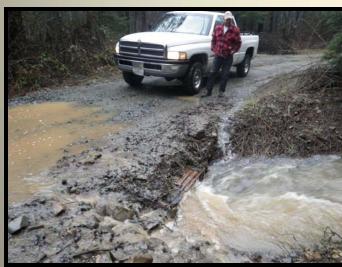
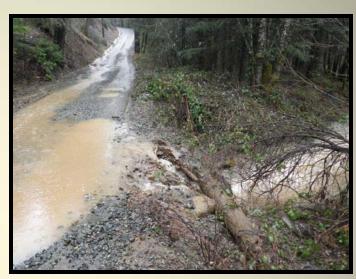
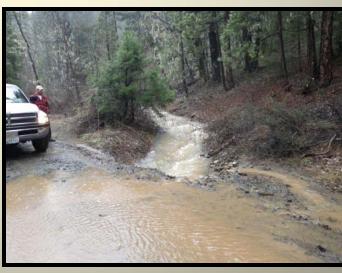
China Gulch Culvert Replacement (2013)

- Private road which required closure for one day to install culvert
- Undersized 30" Mining pipe
- •Headwall height limited our pipe size and so we used a vented ford design with a 48" Pipe Arch aka a Squash Pipe
- Fish barrier
- Stream crossing volume 100 cubic yards

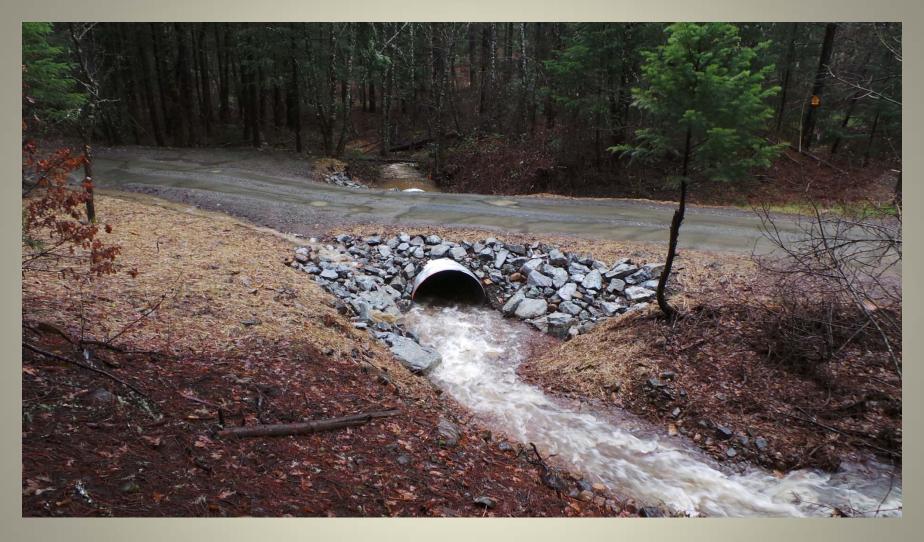
High flow in 2013

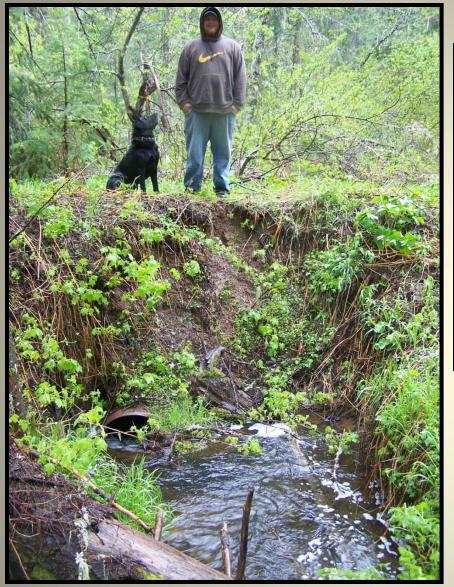
- Live stream during excavation
- Abandoned USFS road
- •Undersized 24" culvert, with chronic plugging issues
- •4' drop over the 50' excavation
- Fish barrier
- Stream crossing volume 200 cubic yards

View of inlet under normal flows, bank erosion and flows over road common occurrence.

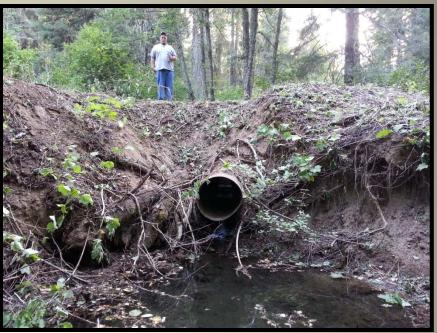
This photo taken just before we excavated the culvert, site has been grubbed of vegetation. You can see where water has went over the road at times and can see the shotgunned culvert which was a fish barrier to resident Steelhead.

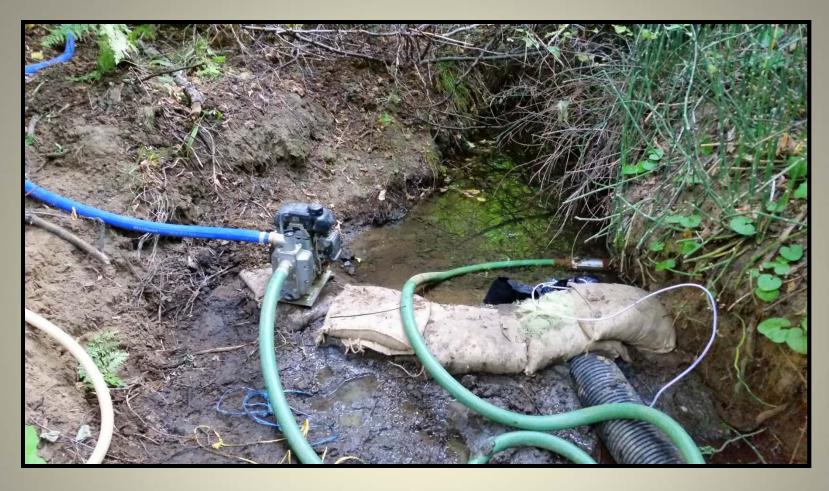
Diverted creek via 6" plastic flex pipe, with small sandbag gravity flow diversion dam, we did partial excavation and then later we plugged flex pipe and used pump to take water around second half of excavation.

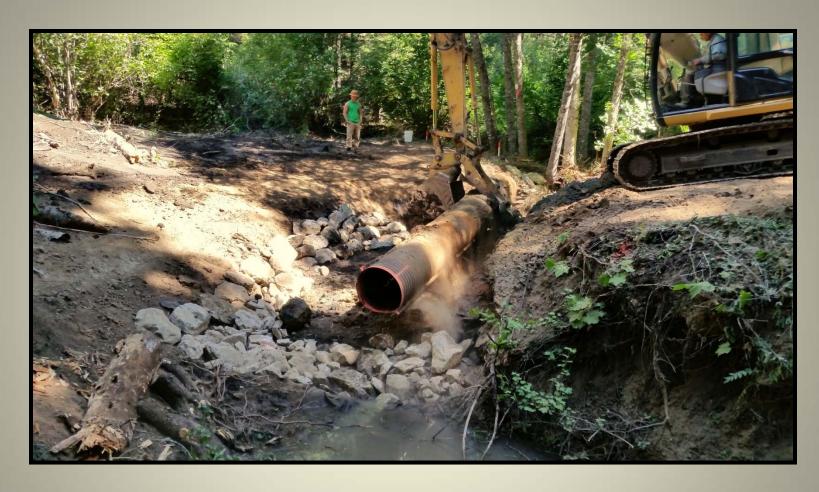
At the time we pulled the culvert, the creek was being diverted (pumped) around the site entering below our construction area.

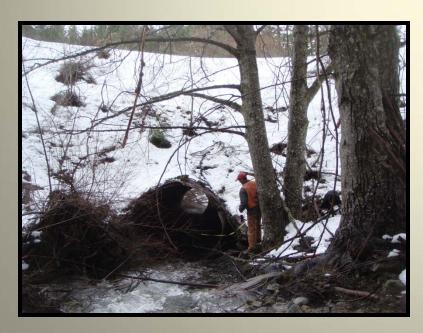
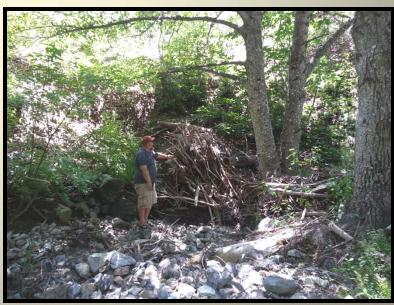
- Abandoned USFS road
- Undersized, plugged and damaged culvert
- Stream crossing volume 4500 cubic yards

View upstream from inside of 84" Culvert on West Fork of Hayfork Creek, before and after plugging event in 2013

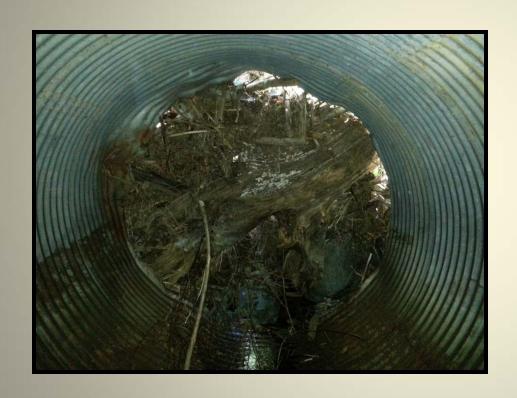
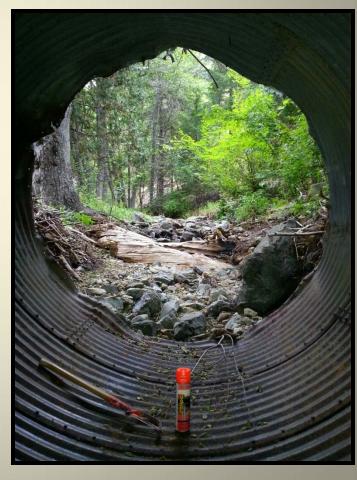
36" Culvert

84" Culvert

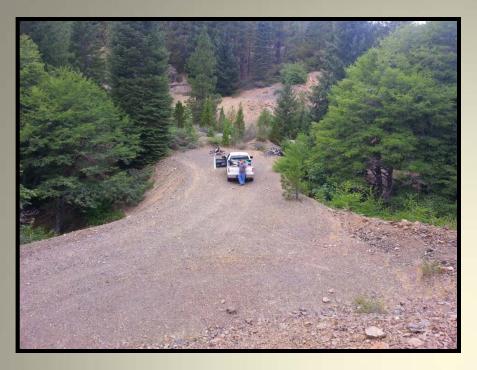
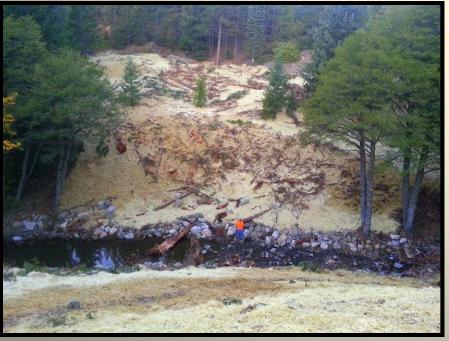
29N35A Total Costs \$103,000

Includes both stream crossings along 0.50 miles of road.

6800 cubic yards excavated from two stream crossings
