# Riparian Vegetation

## Appendix 3

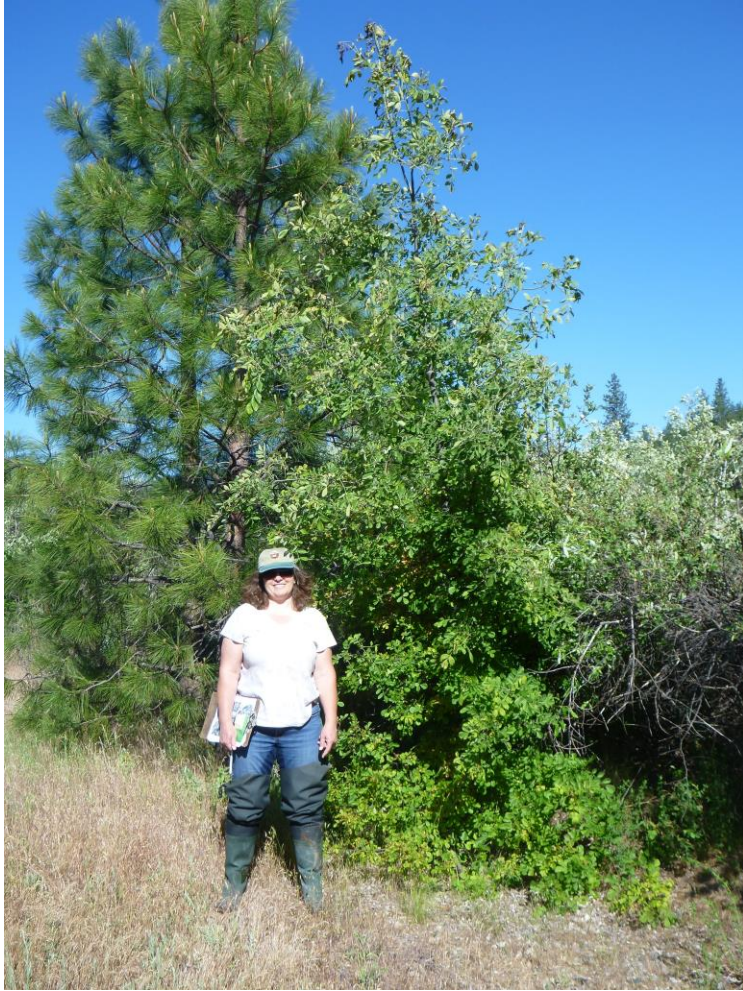
Figure 1: Oregon Ash 2014, 20 years after planting by the Trinity County Resource Conservation District in riparian restoration efforts on Carr Creek. Field technician Donna Rupp of the TCRCD.

The WRTC conducted a small study to determine survival rates at a particular riparian planting project on Carr Creek. The following species were planted and then maintained with watering by NRCS and TCRC D staff: Of 11 Oregon ash, all had survived 20 years after the planting, most had some drought related crown dieback and two of them had severe dieback. Of 20 Ponderosa pines all had survived and had more than 50% green healthy needles.

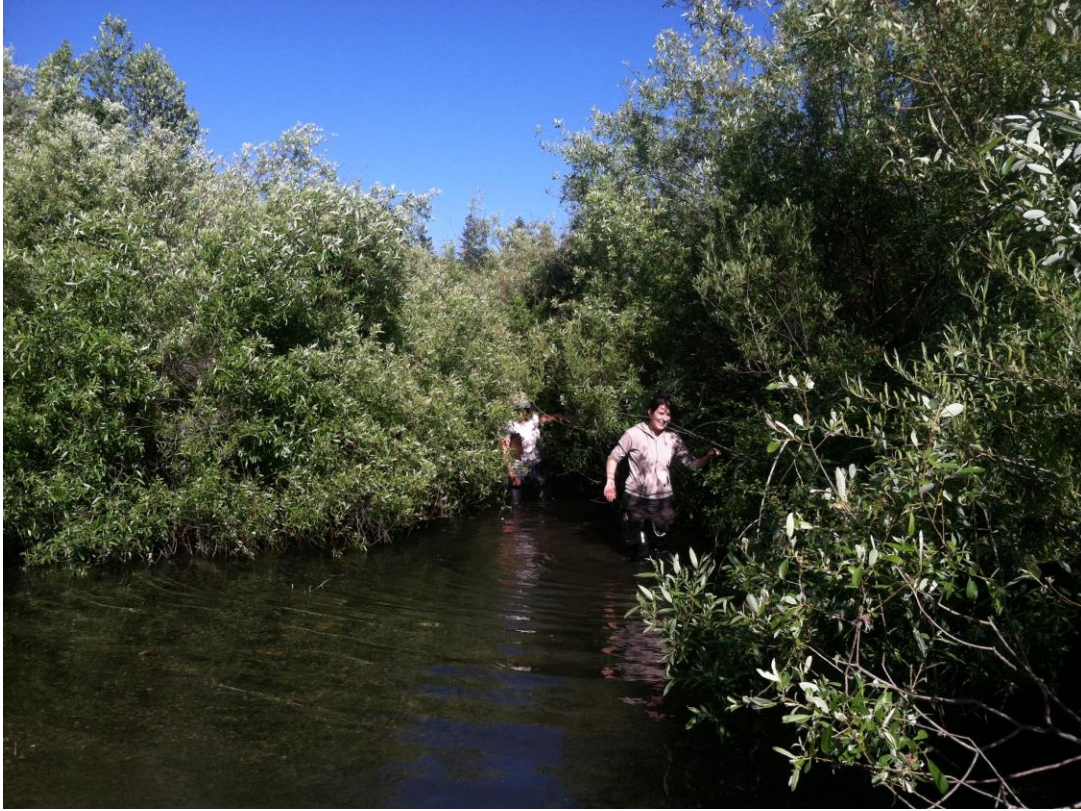
Figure 2: Thick willow has grown in on the Carr Creek planting site 20 years after the restoration project of 1994. Field technicians Theresa Krebs and Donna Rupp assessing riparian vegetation.

A side note on this Carr Creek project, several landowners have indicated that this NRCS and TCRCD project created a thick cover of willow that engulfed the stream (Figure 2). When we reviewed the planting documents, it appeared that no willow, cottonwood, or alder varieties were planted. It is curious as to why willows colonized so successfully after the planting work; possibly due to other factors like changing hydrology or beaver eradication.

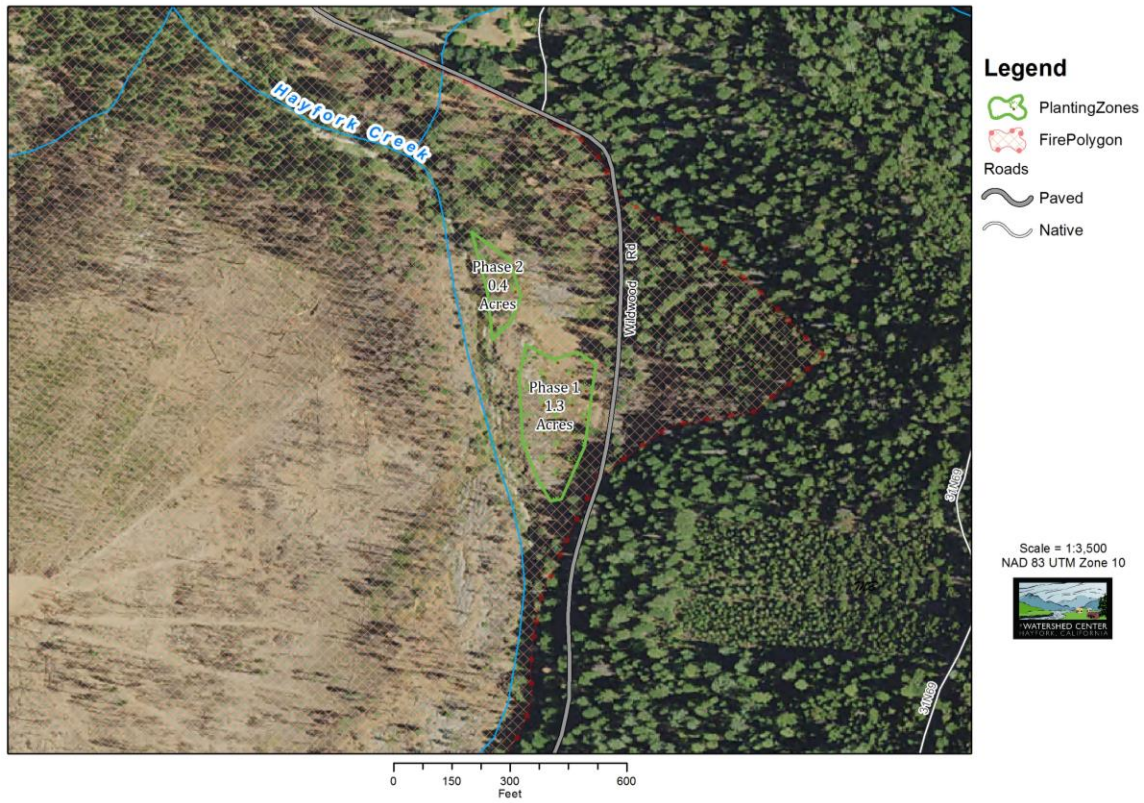
Figure 5: Stafford Fire “Ignition Site” Revegetation Project Map.

The Stafford ignition site was chosen due to wildfire impacts on Hayfork Creek. The Stafford Fire burned 4,403 acres in the summer of 2012; 903 acres were burned at high severity. This high intensity wildfire decreased riparian vegetative cover along approximately 6 miles of Hayfork Creek and an additional 22 miles of its tributaries (Figure 5). Due to a variety of conditions on site, planting design was implemented in two phases with guidance from James Lee, Riparian Ecologist.

Phase 1 occurred in March 2014. Prior to phase 1 of the planting efforts, the Forest Service Silviculture crew pre-dug 73 holes adjacent to a nurse feature that can provide afternoon shade. Five Valley High School students, community members, and a Riparian Ecologist assisted Watershed Center staff with planting conifers. Two year old Douglas-fir, incense cedar, and ponderosa pine saplings were planted. Dry water (a plant based cellulose gel which slowly releases water into the soil) was placed in a PVC tube, and placed in each hole at a 45° angle, to deliver 3 months of moisture to the roots. Starting four months post planting, the saplings were watered once per month. Even with dry water and irrigation, extreme drought resulted in 100% mortality of the incense cedar and 85% mortality of other conifer saplings.

Phase 2 occurred in March 2015, immediately above Hayfork Creek. This area historically had oaks and other hardwood species; however, wildfire and mining impacts have left it without overstory shade. Some re-sprouting of fire impacted hardwood trees was observed, but not enough to provide sufficient shade to the creek. Hayfork Elementary School kindergarteners assisted Watershed Center staff in planting Oregon white oak acorns. 50 holes were planted at a rate of 3 acorns per hole. All acorns planted were previously collected from the Hayfork Valley.

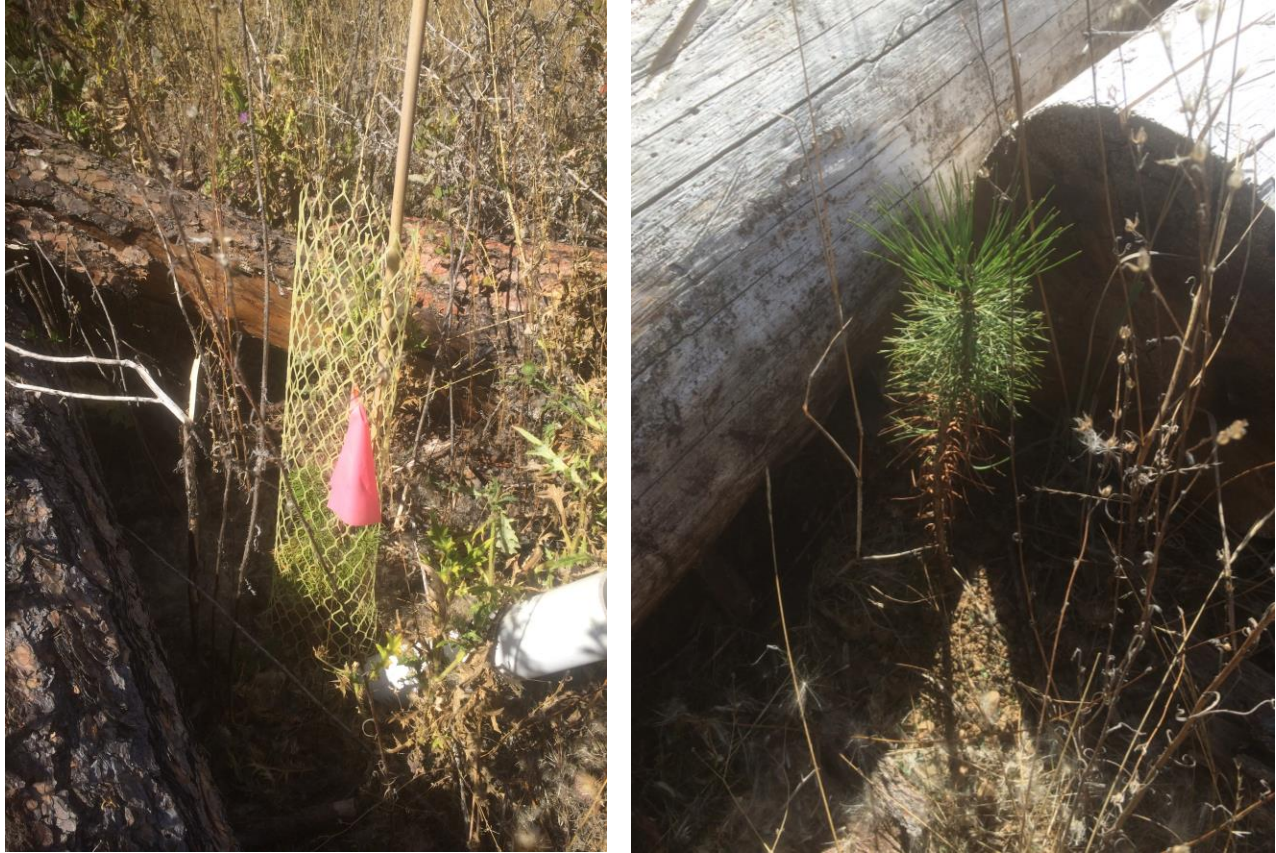
Figure 6. Stafford Fire “Ignition Site” Revegetation Project. a) Douglas-fir seedling with deer protection and dry water tube. b) Ponderosa pine seedling strategically placed near nurse feature for afternoon shade generation.

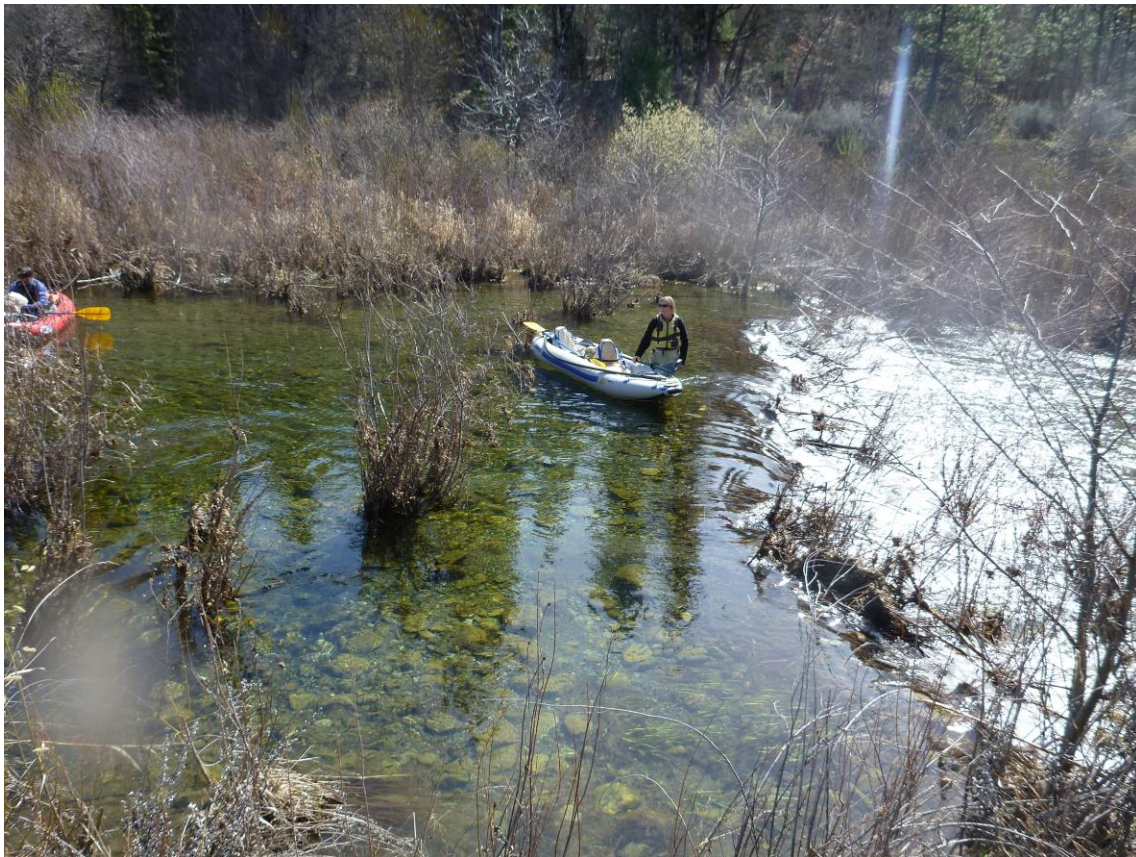
Figure 10. Beaver dam at Hayfork Creek

**Beaver Activity:** While beavers seem to help overall riparian vegetation growth, they also use riparian vegetation as a primary food source. Another potential management tool that could be utilized to promote and speed upstream shading is fencing to protect riparian trees. Allowing a selective alder and cottonwood trees to grow may contribute greatly to overall streamshade.
