Fish Passage

Appendix 5

**FIELD SURVEYS AND VISUAL ASSESSMENTS
OF THE FEASIBILITY OF
HANDWORK TO RESTORE FISH PASSAGE TO TRIBUTARIES IN THE
SOUTH FORK OF THE TRINITY RIVER WATERSHED,
TRINITY COUNTY, CA**

By
Samantha D. Chilcote, PhD

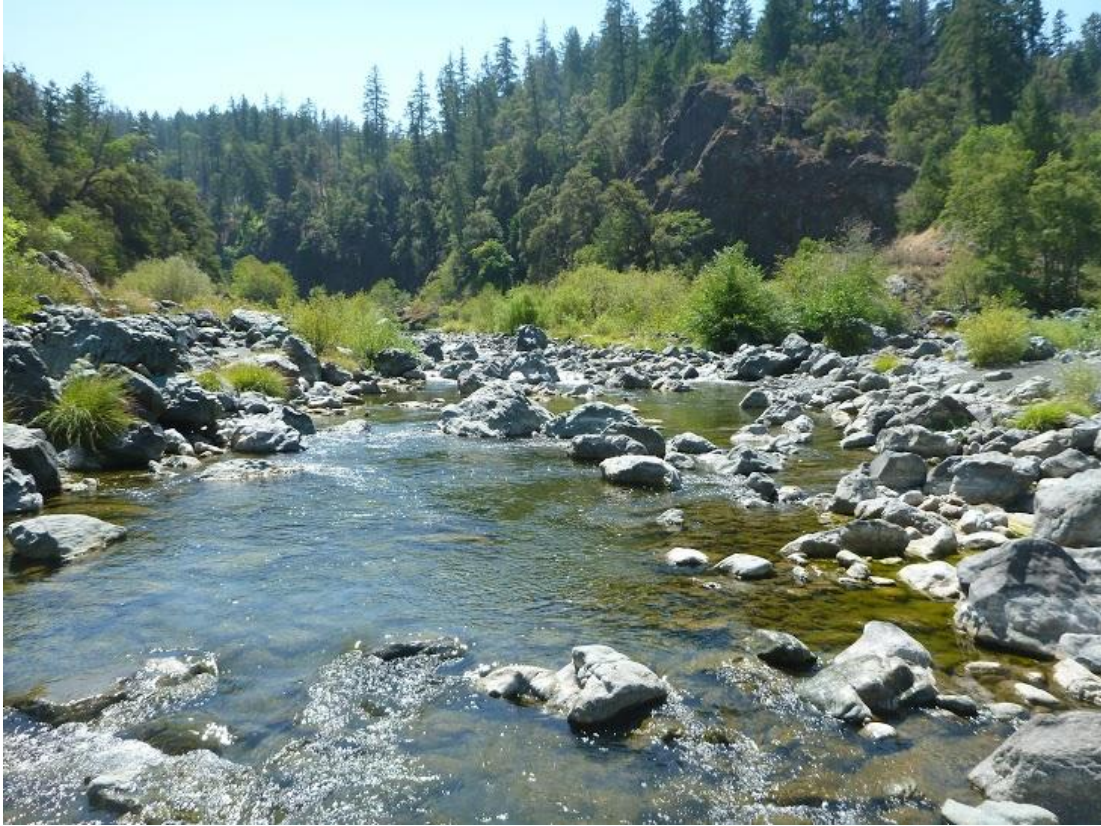
Figure 7. Mouth of Grouse Creek.

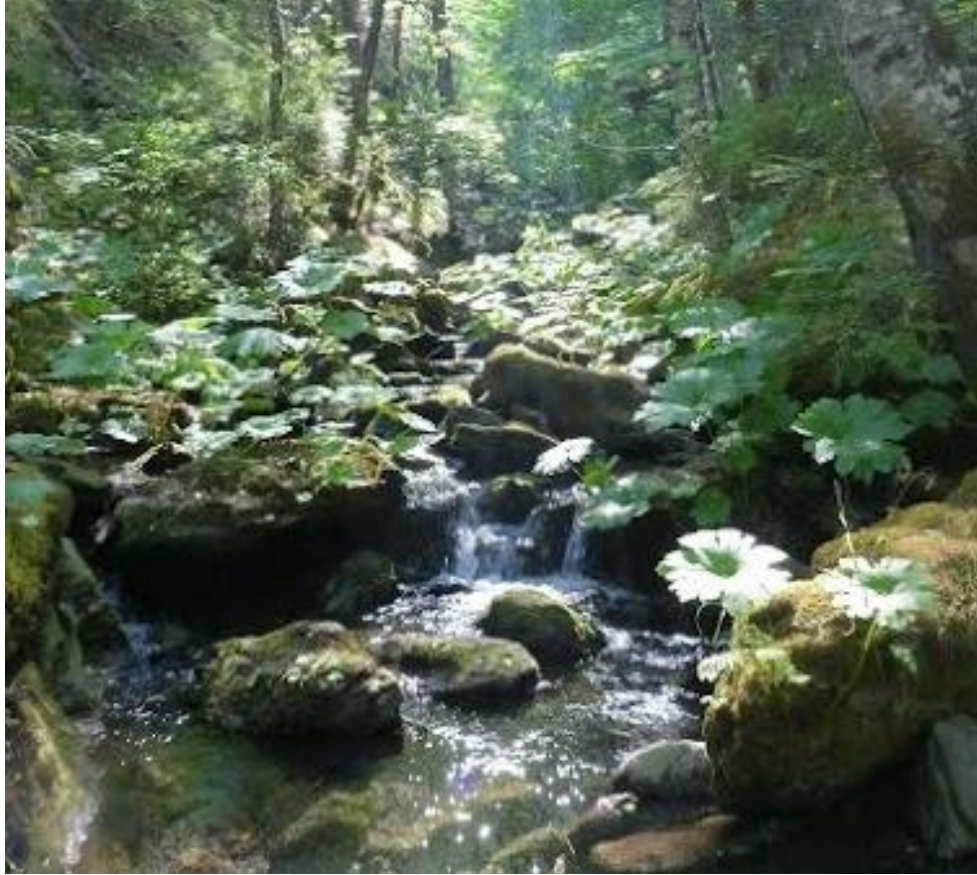
Figure 8. Rough Gulch at low flows.

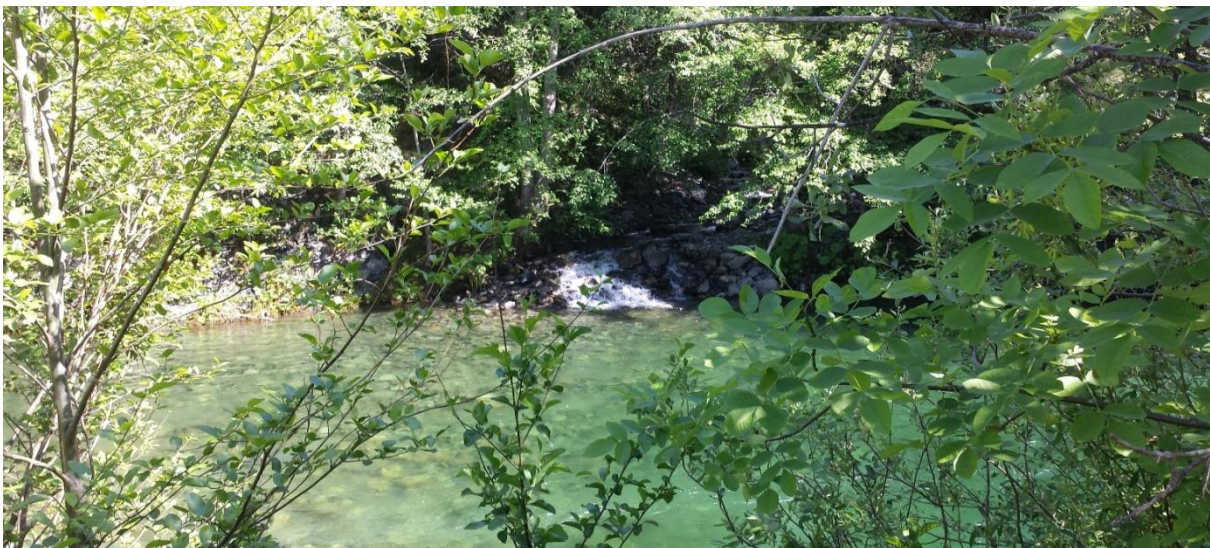
Figure 9. Little Bear Wallow mouth at low flow conditions.

Grouse Creek, Little Bear Wallow and Rough Gulch were not qualitatively assessed. These sites are very remote and time consuming to access and assess. As such, they were only visually assessed and do not have detailed design descriptions. cursory visual assessments indicate that each of these sites would

benefit from handwork to support increased fish passage. More in-depth assessments of these areas is recommended.

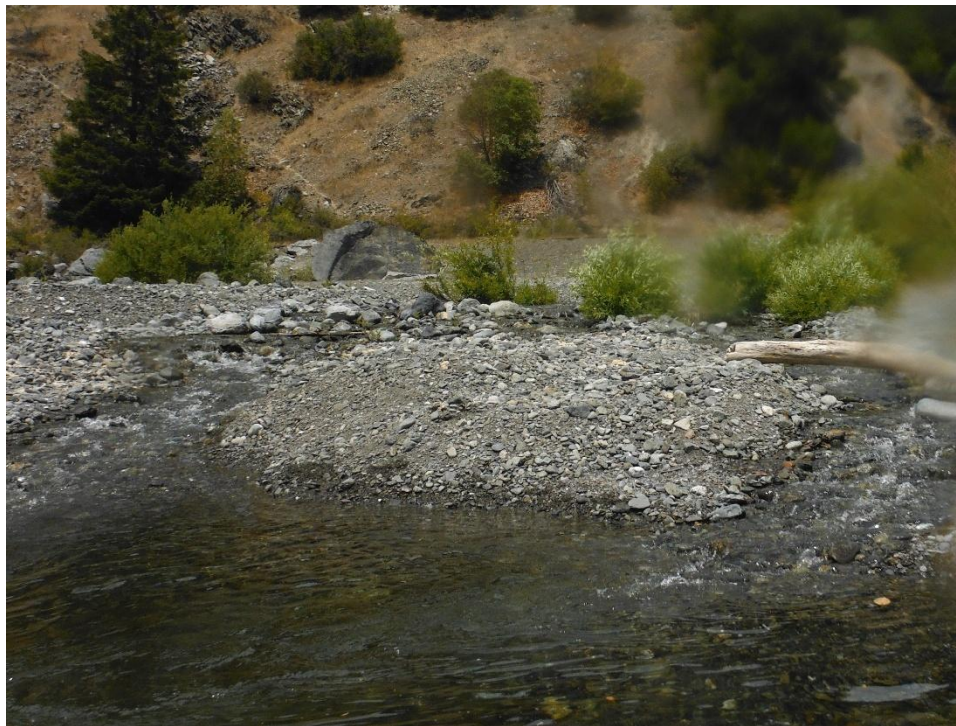
Mouth restoration by handwork would be sufficient to restore passage from SFTR to Madden Creek (Figure 10). Although the creek is hydrologically connected by surface flows, the gradient at the mouth is fairly steep due to aggradation at the mouth.

Figure 10. The mouth of Madden Creek.

Handwork is recommended for enhancing fish passage at the mouth of Madden Creek. This area has a high gradient and would be enhanced by concentrating flows from the five channels into a single thread, reducing the gradient, and providing slower velocity resting areas for juvenile passage. Handwork should reduce the gradient from the confluence with the SFTR for 24.5 meters upstream. The vertical drop over this length is approximately 1.2 meters resulting in a stream gradient of 4.9%, with much of the vertical drop concentrated in the lower portion of the creek. Because coho salmon prefer gradients below 3% (Reeves et al, 1989), we recommend reducing the gradient with handwork at the mouth to below 3% by utilizing small step pools.

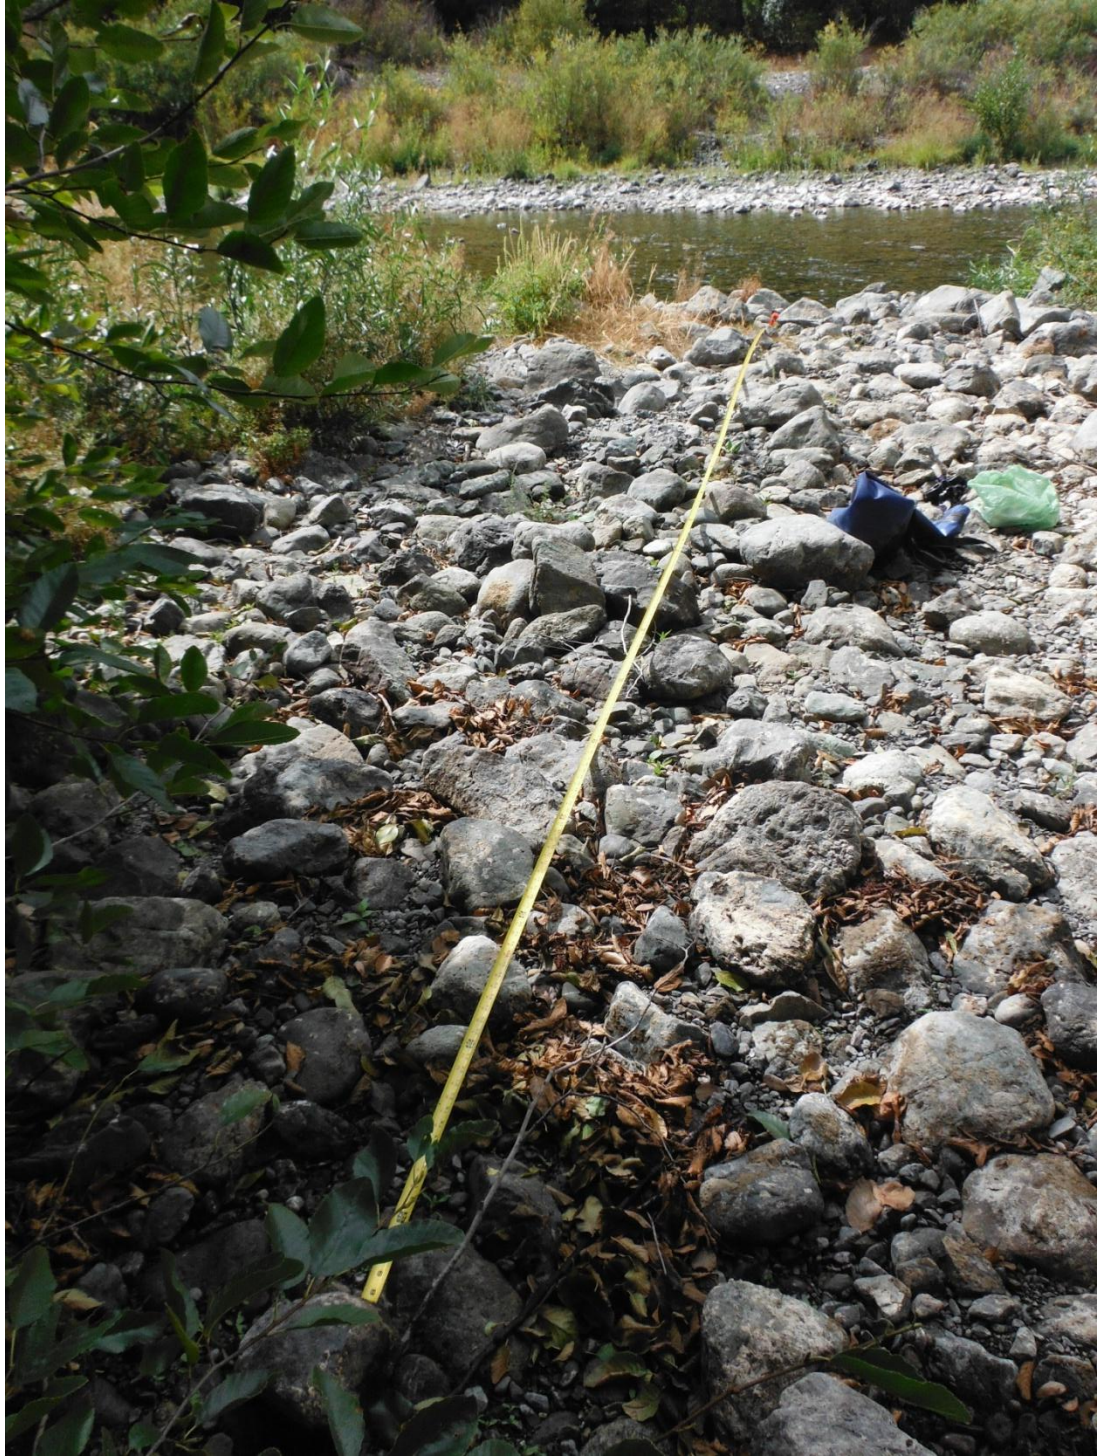
Handwork would be sufficient to restore fish passage to Eltapom Creek. Eltapom Creek was perched at the mouth with sediment accumulation causing the stream to go subsurface 12.3 m from the confluence with the SFTR.

Figure 12. Eltapom Creek where the stream goes subsurface, looking downstream at the confluence with the SFTR.

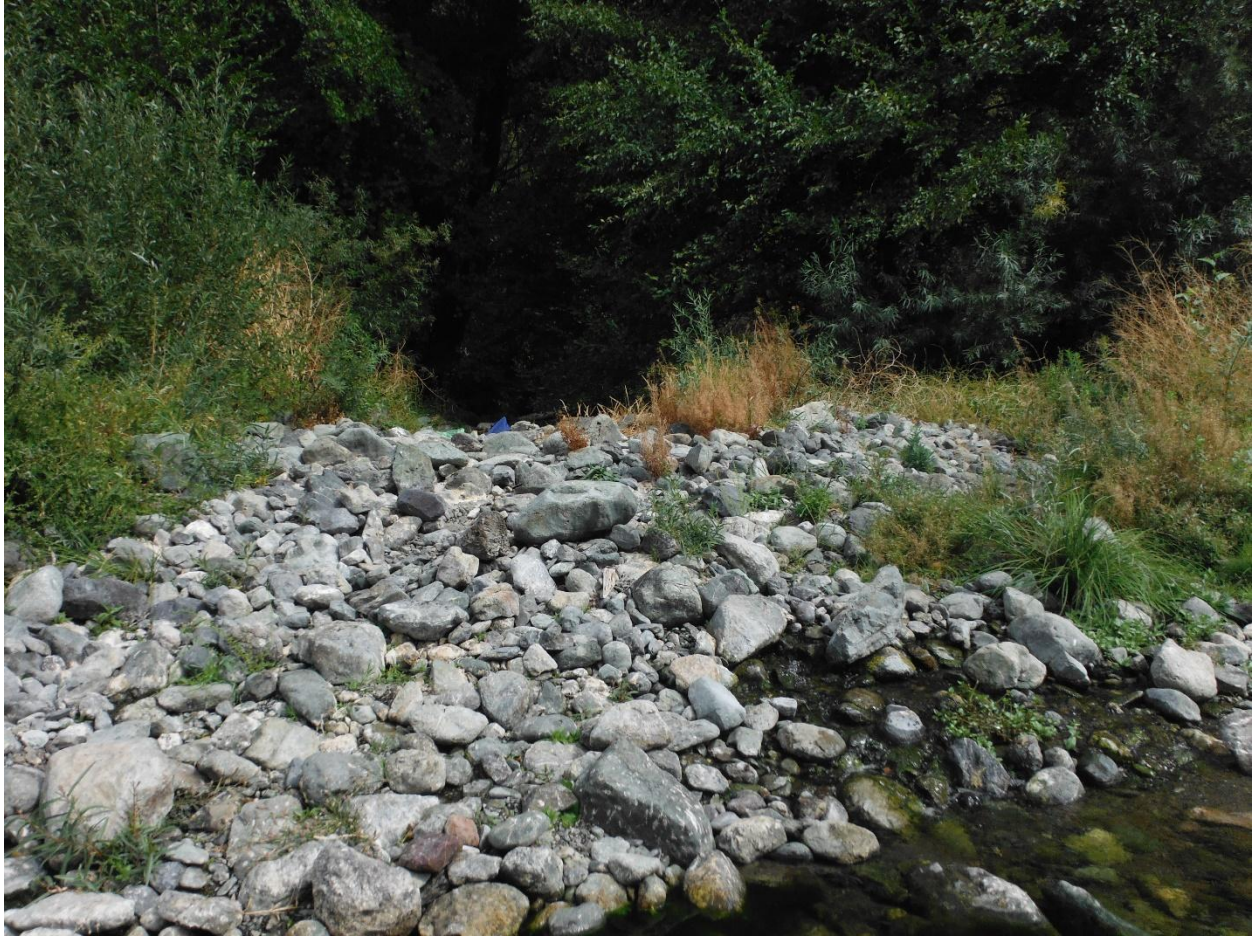
This eliminates fish passage for all species and life history stages at base flow. The subsurface flow reemerges just above the confluence with the SFTR.

Figure 13. Subsurface flow from Eltapom Creek at the confluence with the SFTR.

This is a good indication that handwork would be sufficient to restore surface hydrologic connectivity. There is also a steep slope from the elevation of Eltapom Creek's bed to the SFTR as can be seen in Figure 11. The slope is approximately 35.3%.

Currently, fish passage into Eltapom Creek during summer baseflow is limited by surface hydrology and the gradient at the mouth. Handwork to remove sediment from the subsurface portion of Eltapom Creek would also serve to reduce the gradient at the mouth. A single channel should be cleared along the 12.3 m subsurface section, establishing surface hydrologic connectivity. This will also reduce the gradient by dispersing the 1.8 m difference in elevation between the stream bed and the mainstem over 12.3 m as opposed to the current distance of 5.1 m. The remaining reduction in stream gradient can be achieved by using handwork to construct step pools.

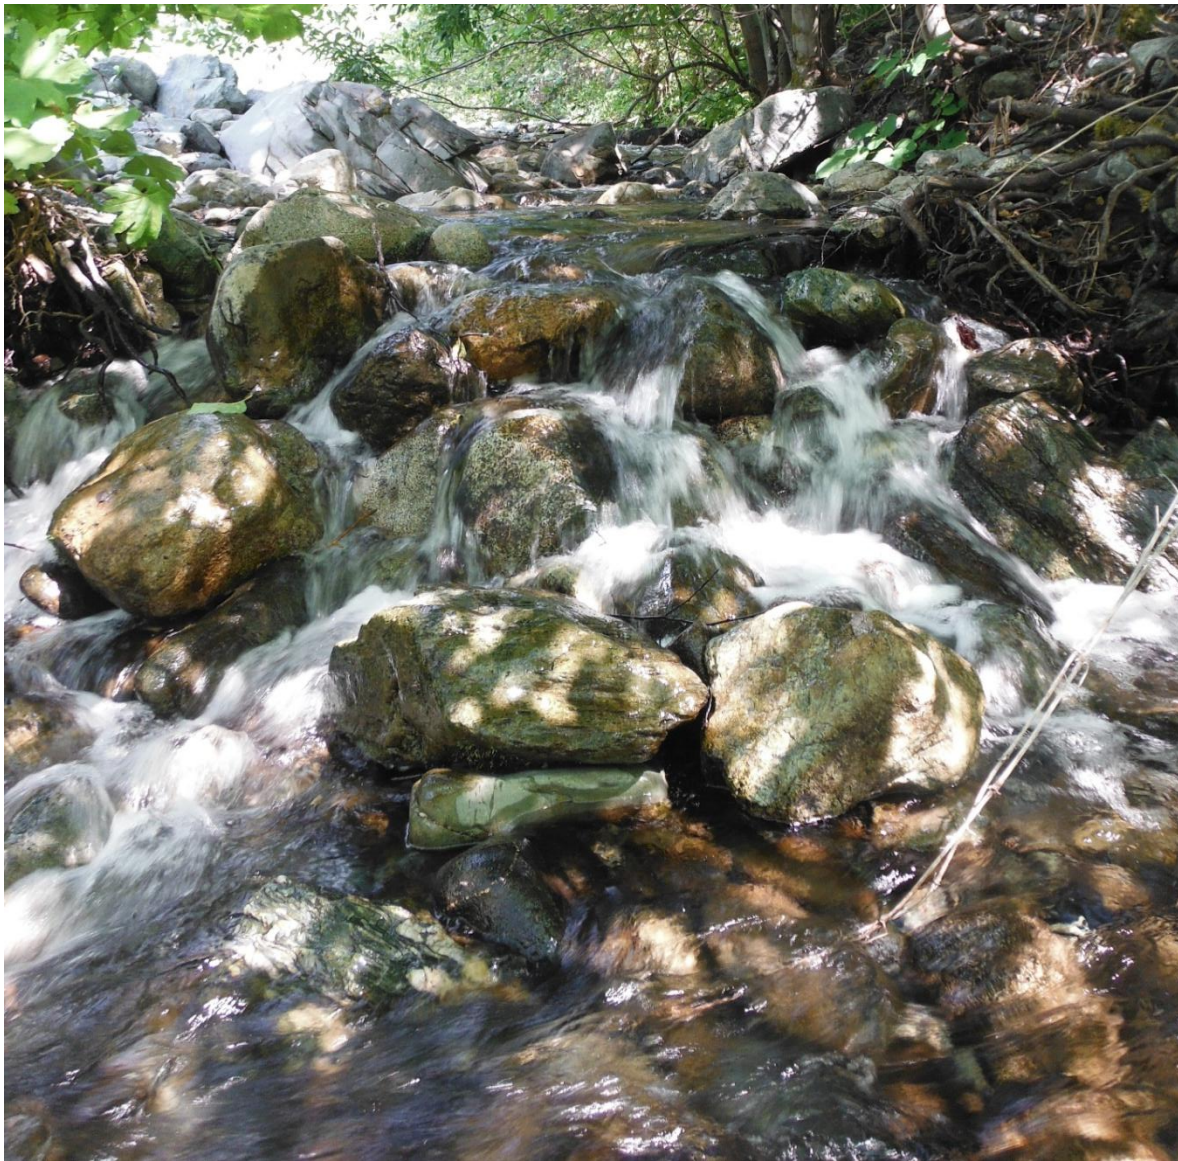
Plummer Creek had a high species richness and was connected by surface water to the SFTR at historic base flows. However, there was a high gradient at the mouth. Therefore, fish passage would be enhanced by hand work which could decrease the gradient at the mouth and provide resting areas for fish as they navigate through it.

Figure 14. Mouth of Plummer Creek.

Currently, the gradient at the mouth of Plummer Creek is 37.5% and there are few pools for resting areas for juvenile fish as they pass. Hand work would be useful to reduce the gradient and create pool habitats for resting areas for juvenile fish as they navigate drops.

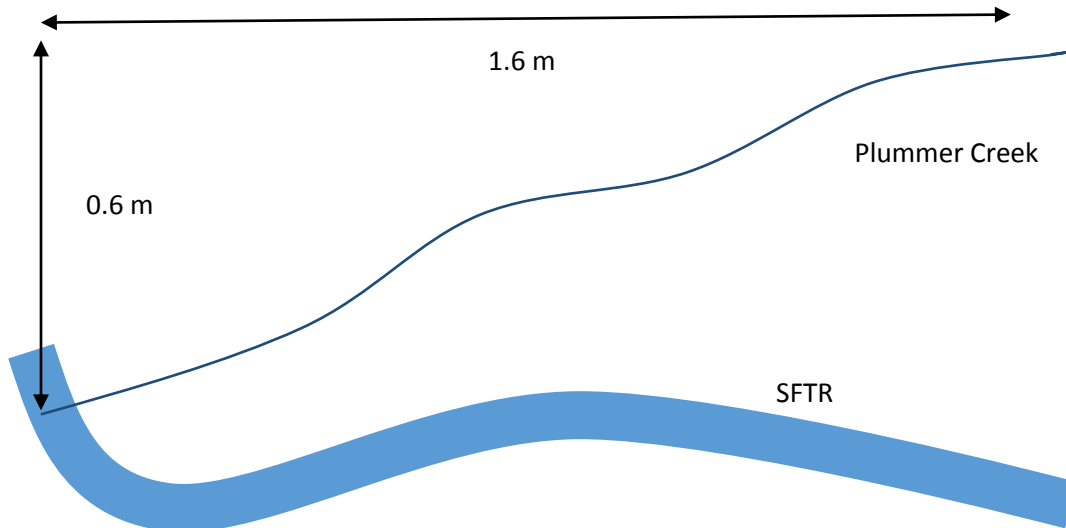
Figure 15. Proposed handwork on Plummer Creek.

The step pools on Plummer Creek would have the same restrictions as Madden and Eltapom Creeks, no vertical drops over 2.3 cm (Whitman, 2011), jump height to landing pool depth 1:1.25 or better (Taylor, 2011), areas with velocities less than 0.0035 m/s (United States Department of the Interior, 1996).

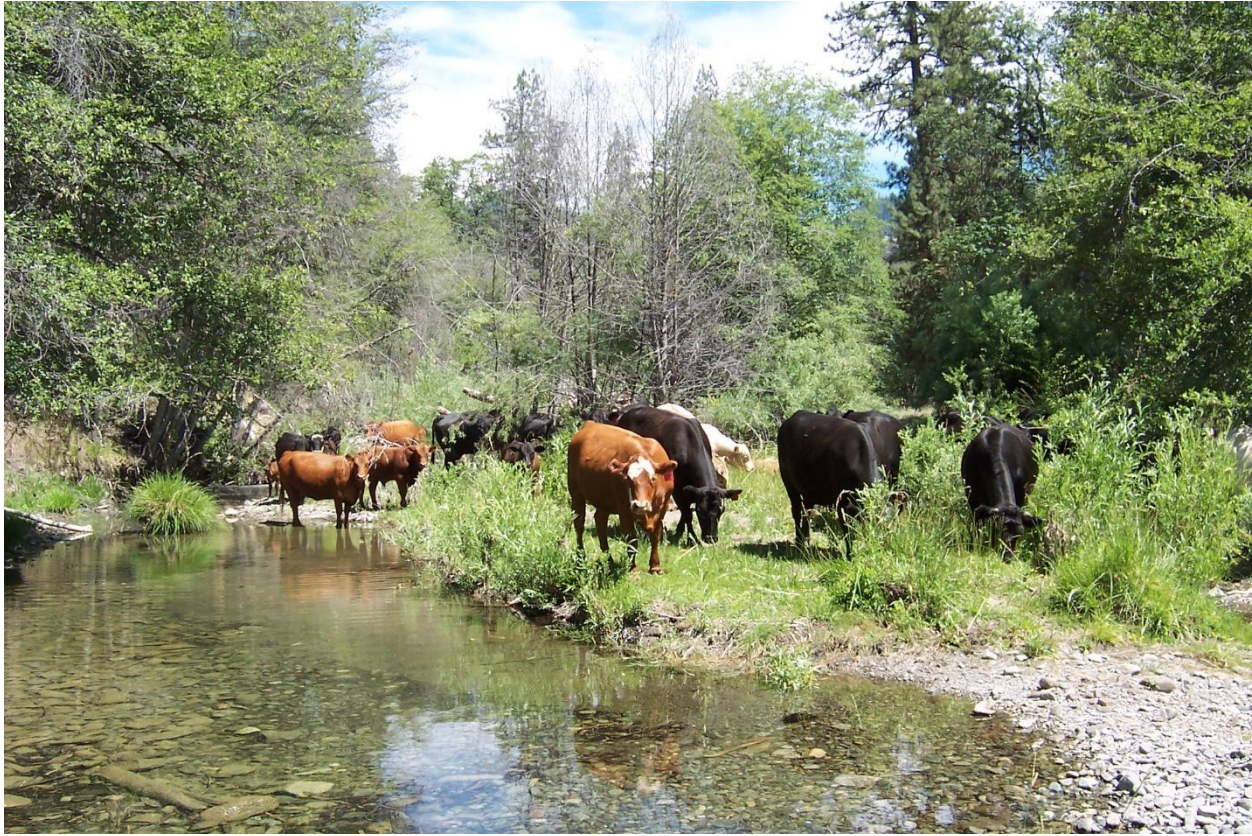
It is important to note that the EF of Hayfork Creek showed signs of impaired water quality, mostly in the form of filamentous algae. This is likely due to cows in the creek. However, there is high quality habitat with good water quality upstream of this area. Therefore, excluding cows from the riparian area would improve habitat quality and restoring surface hydrologic connectivity would restore fish passage to more suitable habitat upstream.

Figure 17. Cows observed near the mouth of East Fork of Hayfork Creek.

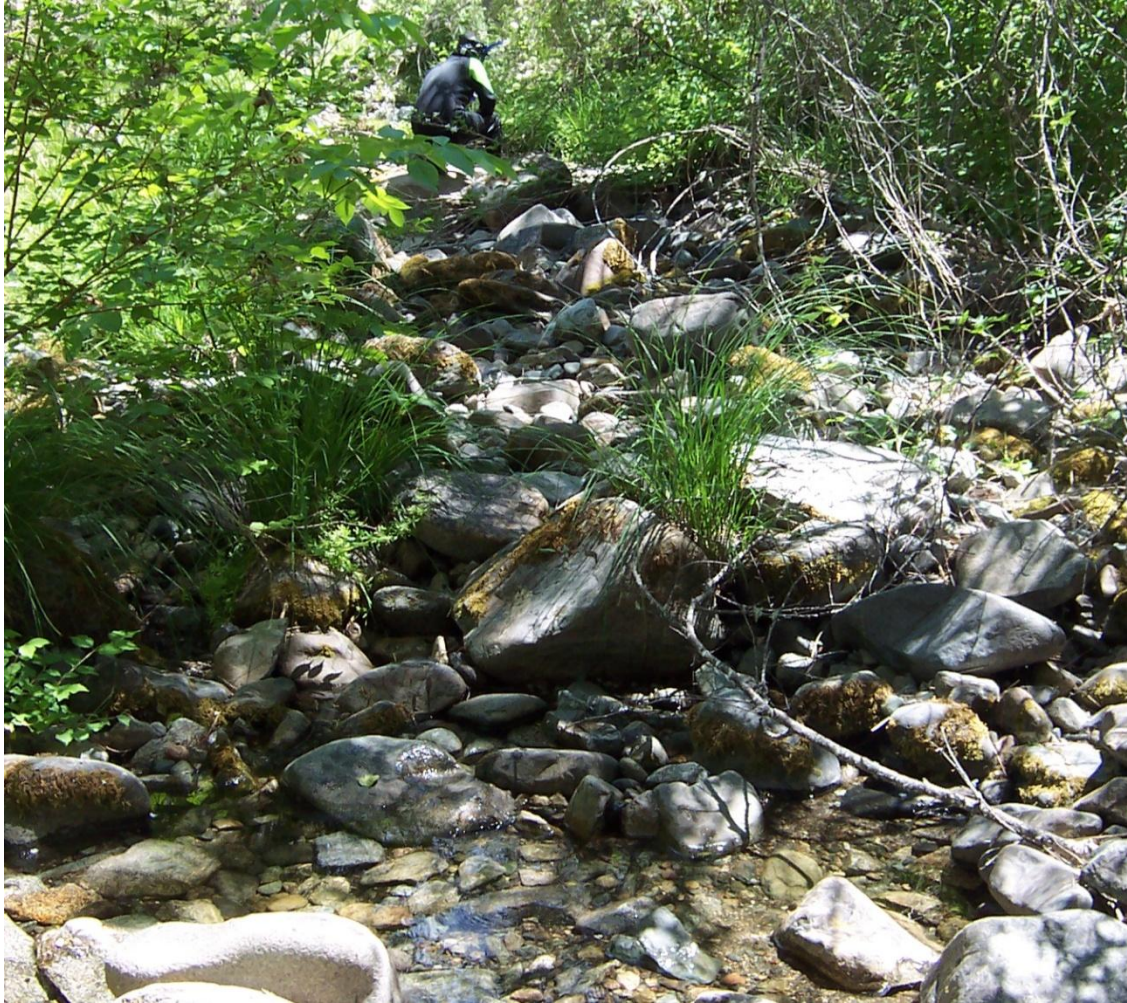
As with Eltapom Creek, Potato Creek would benefit from handwork at its mouth by reducing the gradient, and restoring surface hydrologic connectivity. Potato Creek goes subsurface for 24.5 m approximately 20 meters upstream of the confluence. The mouth of Potato Creek is above the mouth of the East Fork of Hayfork Creek. Therefore, connectivity must be restored in the downstream confluence to achieve restoration results upstream in Potato Creek. These areas are outside of historic occupied coho habitat but contain areas of high intrinsic potential habitat. Therefore, Potato and East Fork of Hayfork Creek offer potential restoration opportunities for coho salmon but also can offer restoration benefits to other species, such as chinook salmon and steelhead/rainbow trout complexes.

Figure 18. The beginning of the subsurface portion of Potato Creek.

Handwork would be useful for removing sediment in the subsurface portion to restore surface connectivity while at the same time reducing the gradient at the mouth. There is an 18.75% gradient in the lower 2.4 meters of the stream. Digging out the subsurface section and extending the 0.45 m rise over a longer distance would improve juvenile fish passage into Potato Creek.

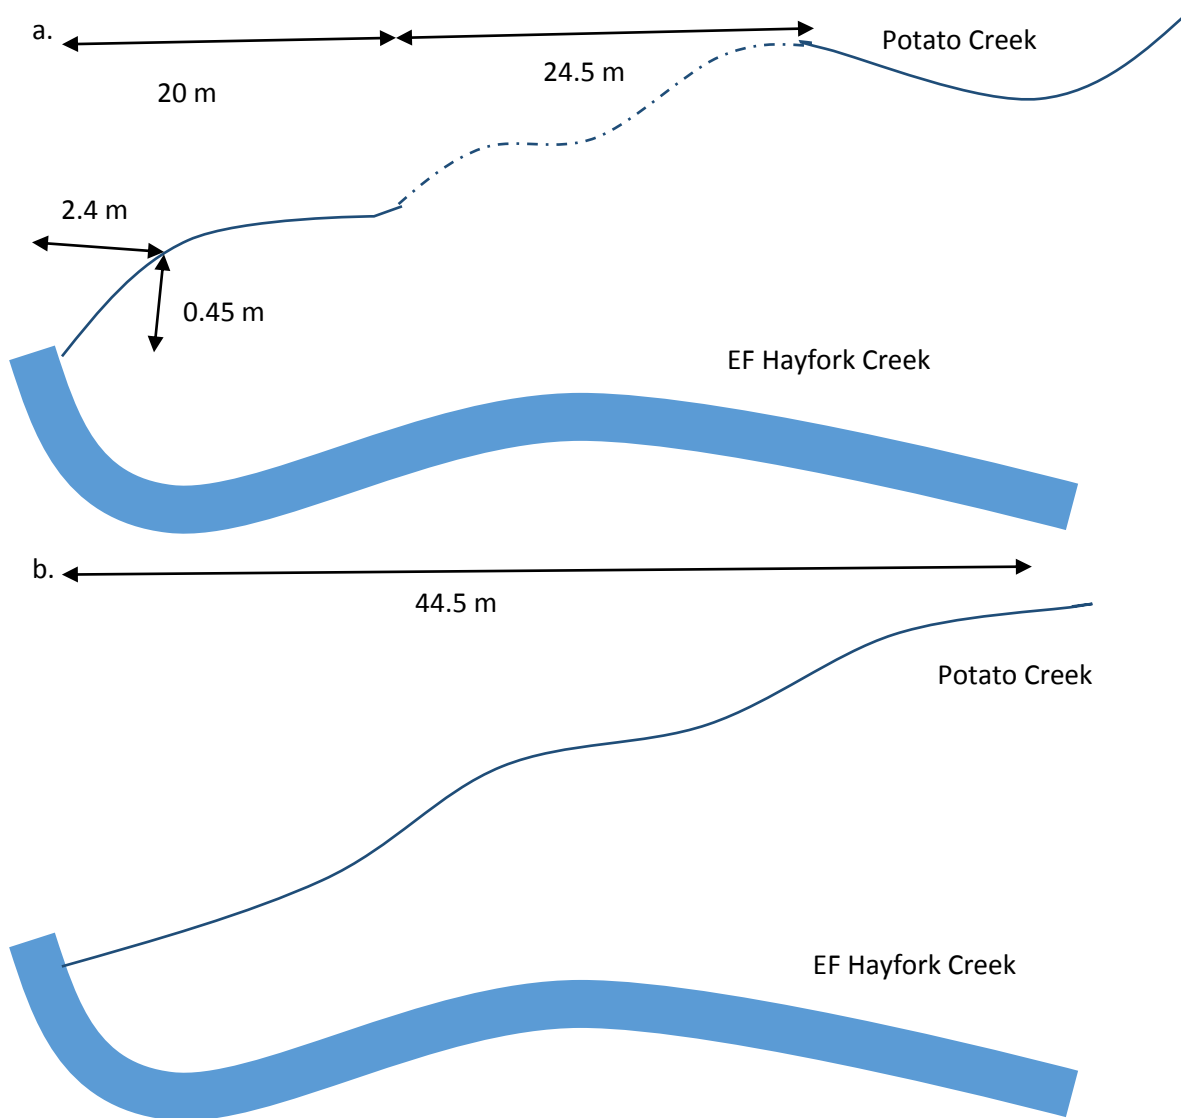
Figure 19. Proposed handwork for Potato Creek. Before handwork (a) and After handwork (b).

Step pools could also be used to lower the gradient. The step pools on Potato Creek would have the same restrictions as for Madden and Eltapom Creeks, no vertical drops over 2.3 cm (Whitman, 2011), jump height to landing pool depth 1:1.25 or better (Taylor, 2011), areas with velocities less than 0.0035 m/s (United States Department of the Interior, 1996).

The rest of the stream is relatively low gradient so dispersing the steepest rise at the mouth over a longer stream length would benefit fish passage while restoring hydrologic connectivity.
