Appendix 4
HABITAT QUALITY, BIOTIC CHARACTERIZATION, AND FISH PASSAGE
ASSESSMENT OF
WATER DIVERSIONS ON NINE TRIBUTARIES IN THE
SOUTH FORK OF THE TRINITY RIVER WATERSHED, TRINITY COUNTY, CA
By

Samantha D. Chilcote, PhD

February, 2016

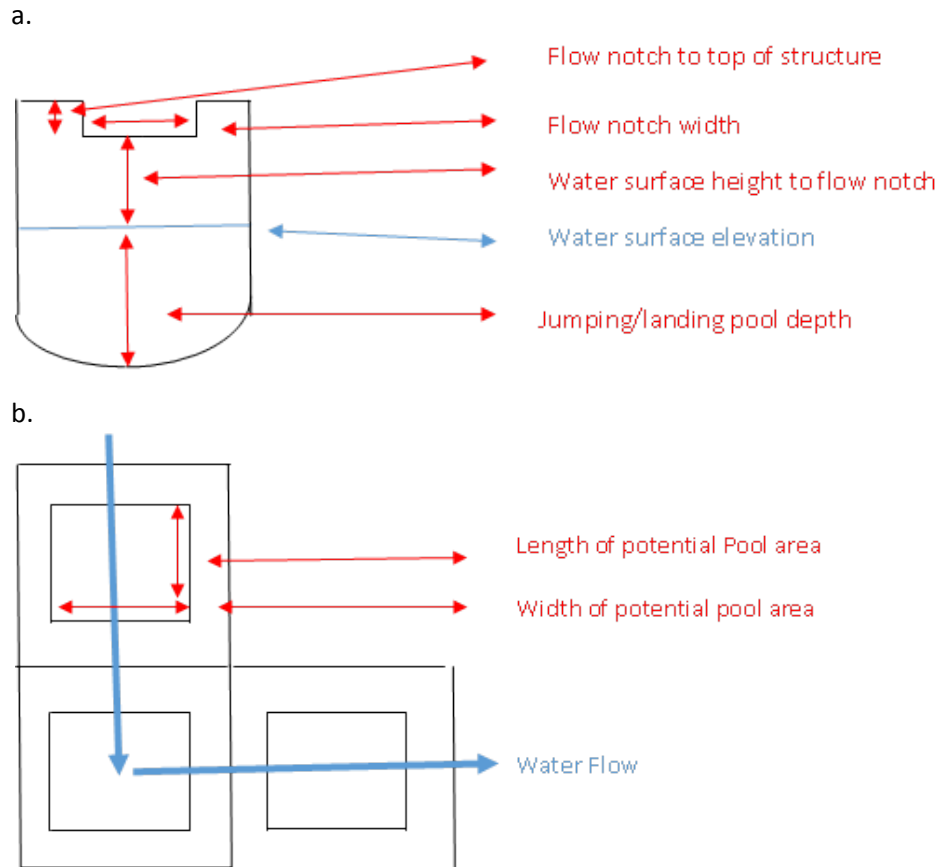
Figure 1. Measurements locations for supplemental measures on a diversion structure. a. looking frontally at a passage structure and b. planar view down on the fish passage structure.
